AGARD CONFERENCE PROCEEDINGS No. 53

## Engineering Practice to Avoid Stress Corrosion Cracking

SYMPOSIUM ON THE ENGINEERING PRACTICE  
TO AVOID STRESS CORROSION CRACKING

Papers presented at the Structures and Materials Panel 29th Meeting  
held at Istanbul, Turkey, 30 September to 1 October 1969.

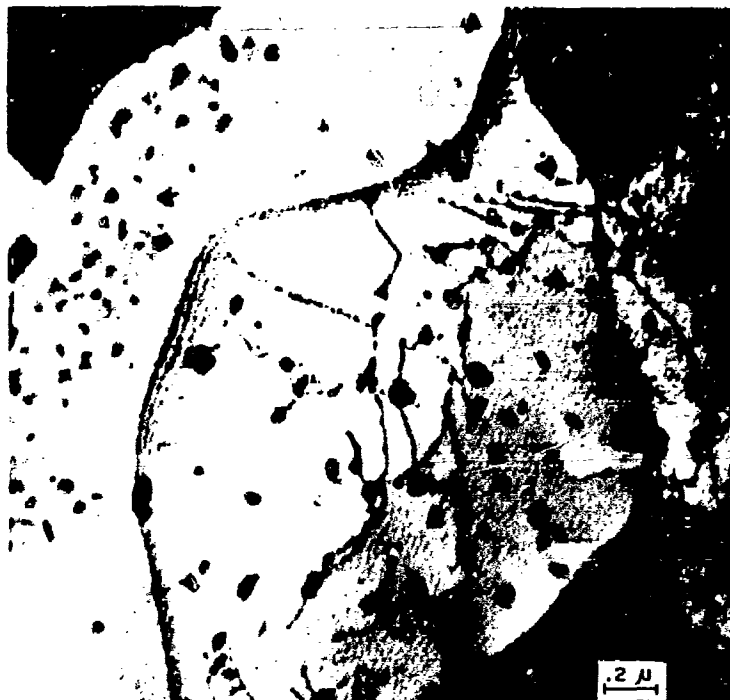
Fig.1 Electron transmission micrograph of thin foil prepared from rolled plate of 7075-W heat treated in the laboratory and quenched in cold water. Dislocations are pinned to some particles of chromium-rich constituent (C) with no visible evidence of zones in the matrix or of M' phase precipitate in the grain boundaries. Short transverse specimens were susceptible to stress-corrosion cracking at 25% Y.S.

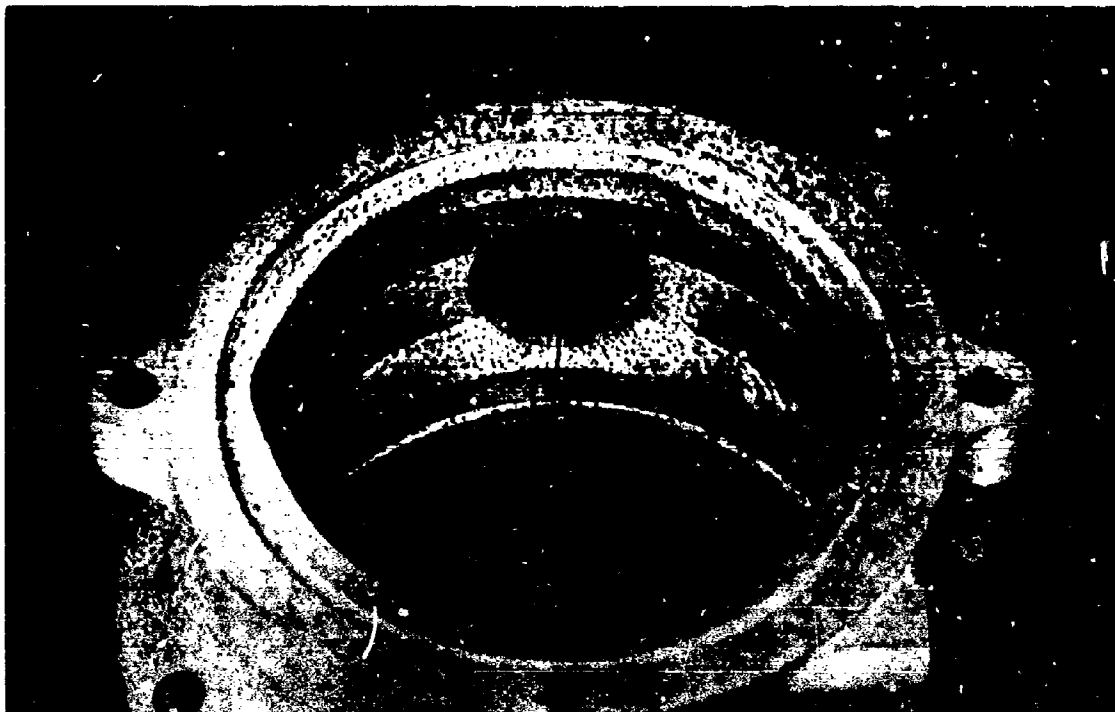
Fig. 22 Machined forging of 7075-T6 alloy showing extent of cracking into forward boss after an exposure of 18 days in the 3% NaCl solution by alternate immersion. This crack is parallel to the metal flow lines of the parting plane and hence is a short transverse failure (Magnified approximately 1X)

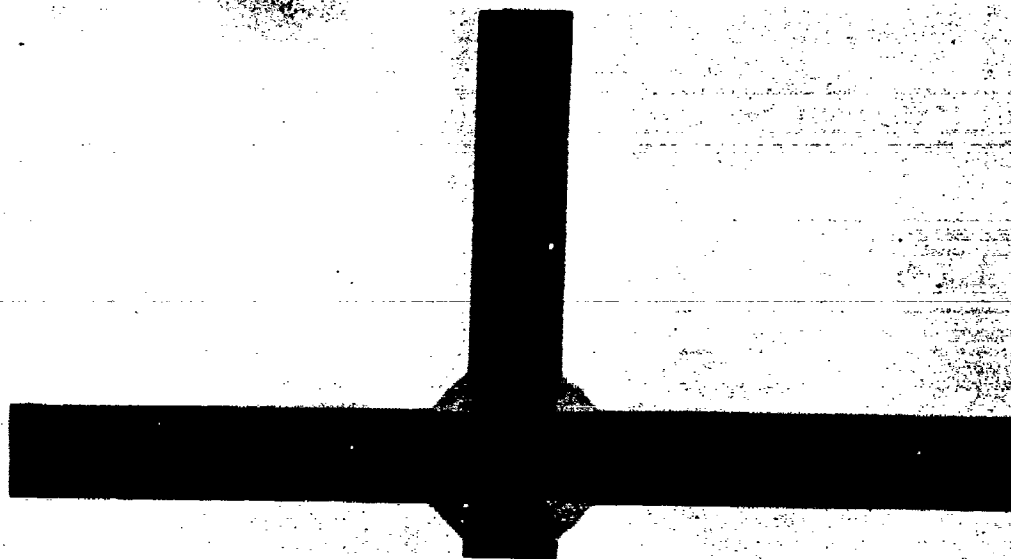
Fig.3 Macroetched 7039 alloy cruciform with through leg cut to 3/4-in. stub length. Original failure occurred after 31 days exposure to an industrial environment. Crack had increased in length at the time of photographing
